MEMORANDUM

To:	Valmichael Leos and Anne Foster, USEPA	Date:	February 21, 2014
From:	Wendell Mears, Randy Brown, David Keith, John Verduin, and John Laplante	Project:	090557-01.04
Cc:	Dave Moreira and Andrew Shafer, MIMC Phil Slowiak, IP		
Re:	San Jacinto River Waste Pits TCRA Armored Cap Enhancement Completion Report

Figure 1
Armored Cap Enhancement Locations
TCRA Enhancement
San Jacinto River Waste Pits Superfund Site

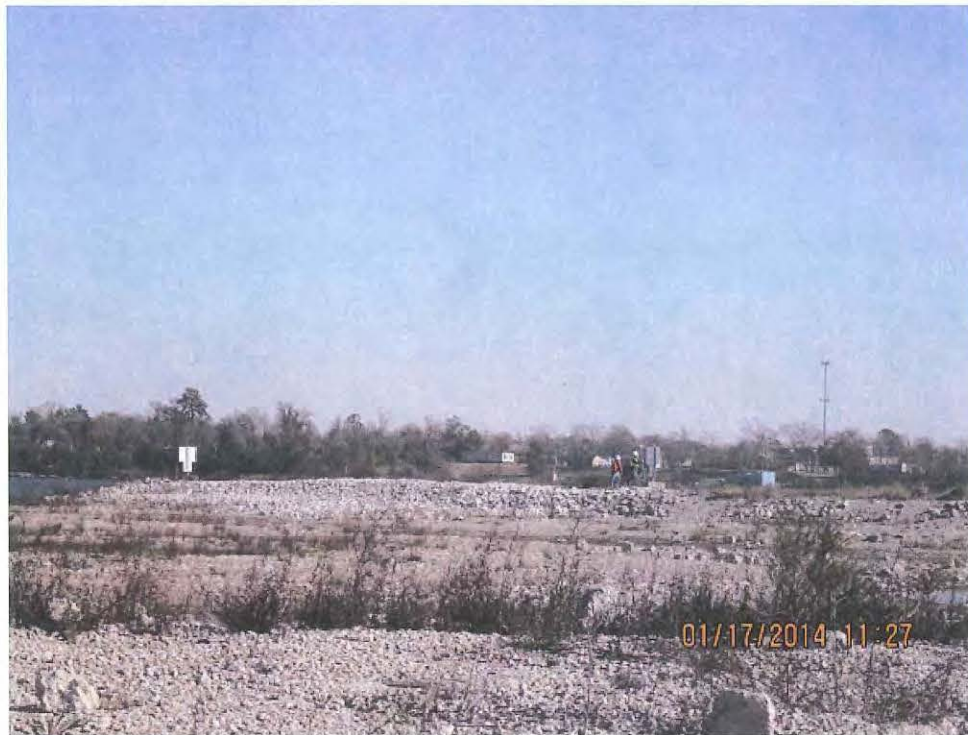
Photo 1 – Hydrographic Consultants perform pre-construction survey.

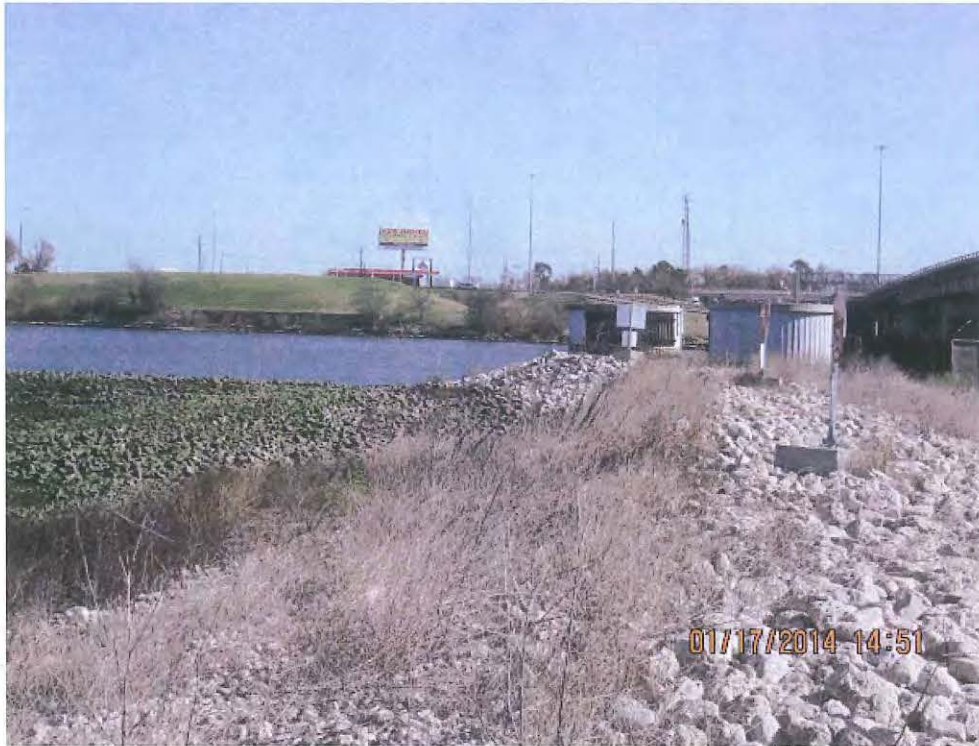
Photo 3 – Areas to receive armored cap enhancement marked along the South Berm.

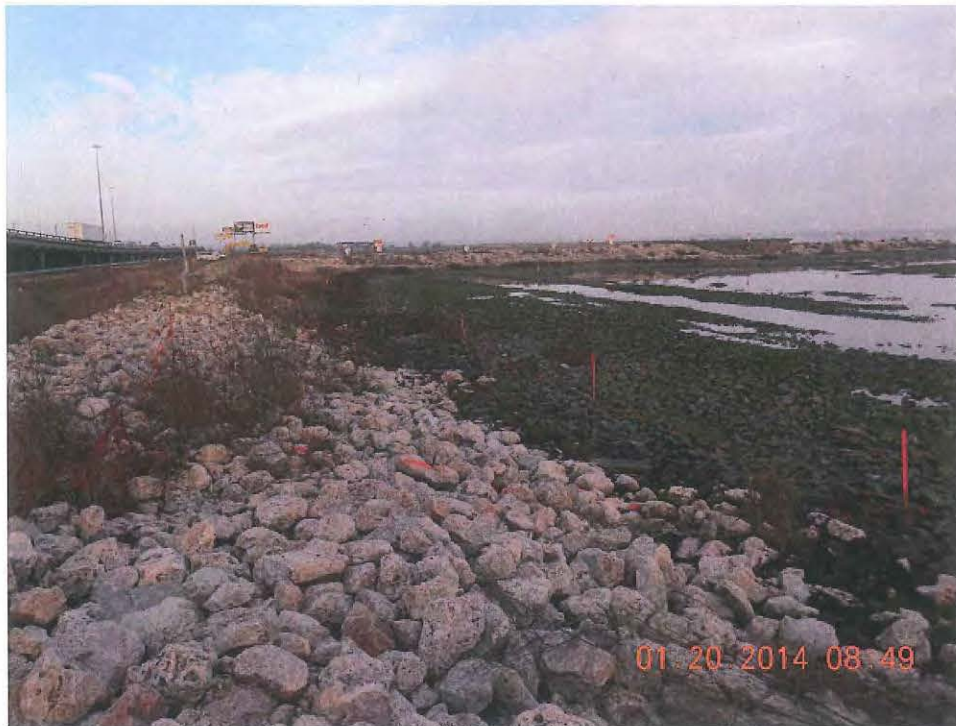
Photo 1 – Enhancement area on South Berm staked out before initiating rock placement.

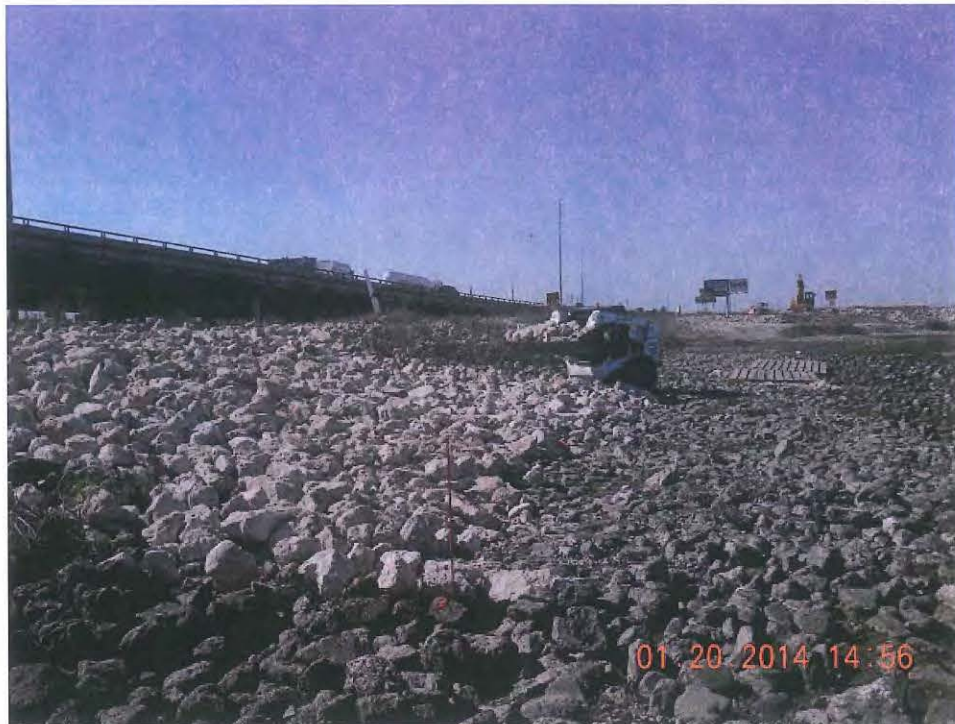
Photo 5 – Skidsteer placing Armor Cap D rock in the South Berm enhancement area.

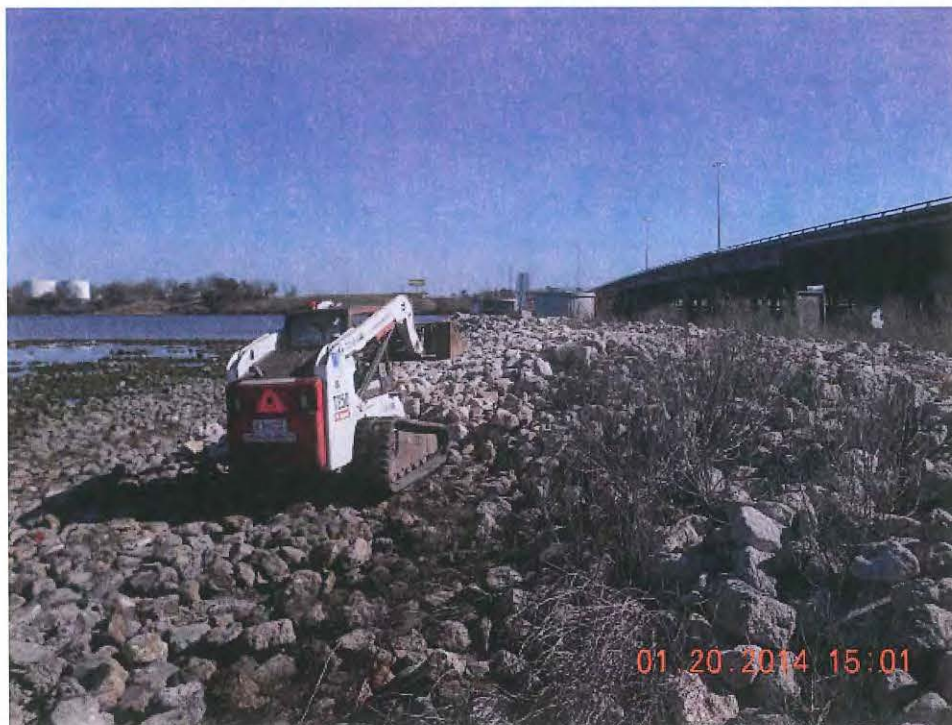
Photo 6 – Skidsteer placing Armor Cap D rock in the South Berm enhancement area.

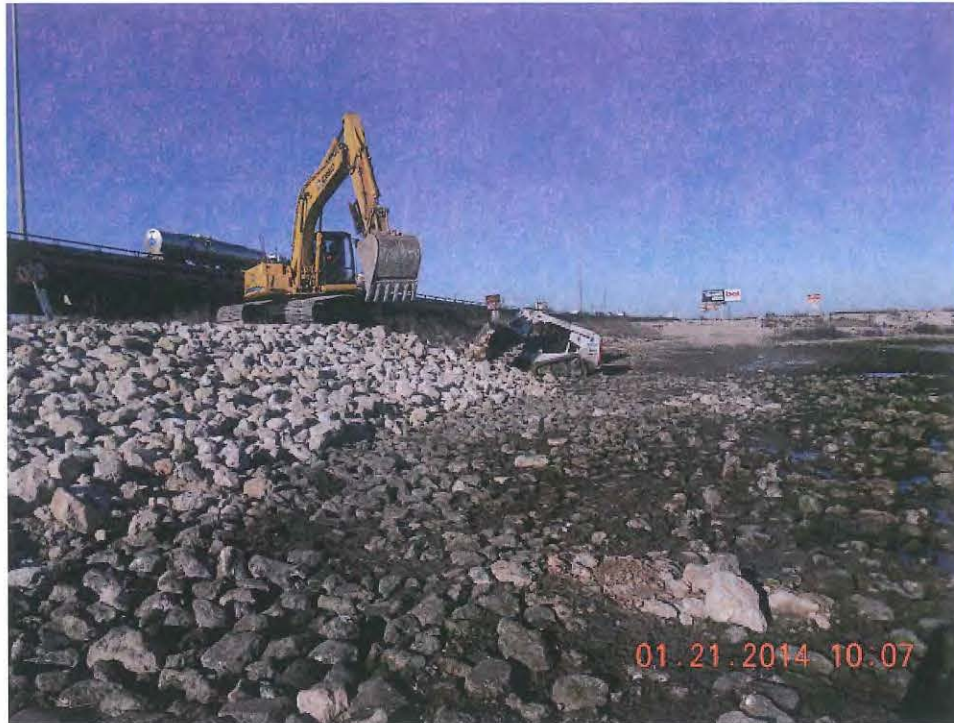
Photo 1 – Placing and grading Armor Cap D rock in the South Berm enhancement area.

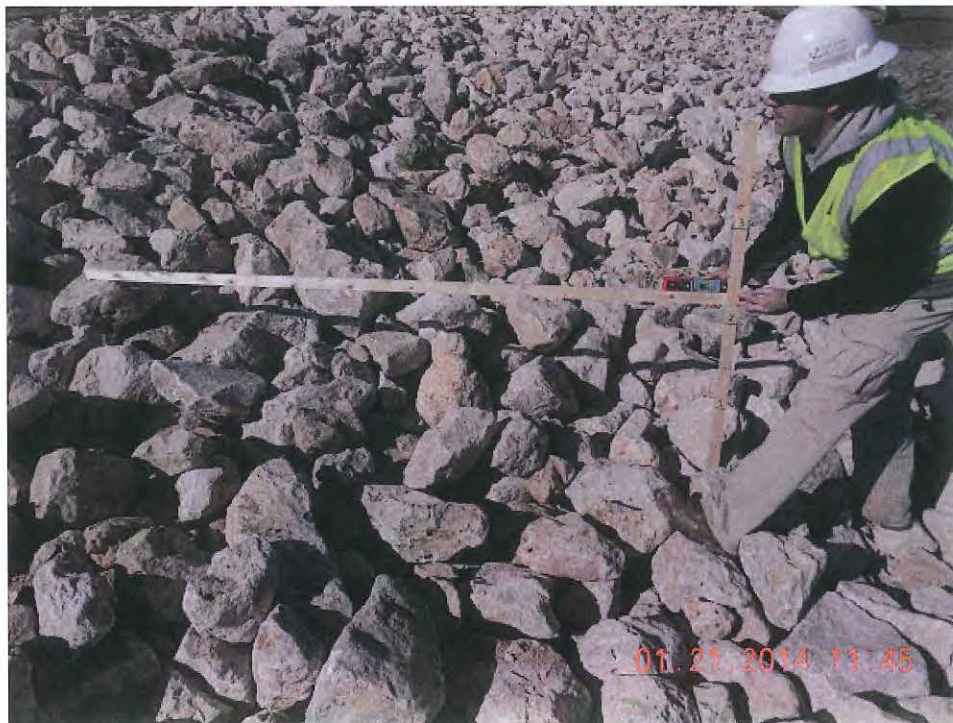
Photo 2 – Using a level to field-check the slope in the South Berm enhancement area.

Before completing an enhancement area and moving to the next, the post-enhancement slopes were field-measured for 1H:3V or flatter slopes at approximately 20-foot intervals using marked wooden boards placed horizontally and vertically atop the armored cap using a field level.

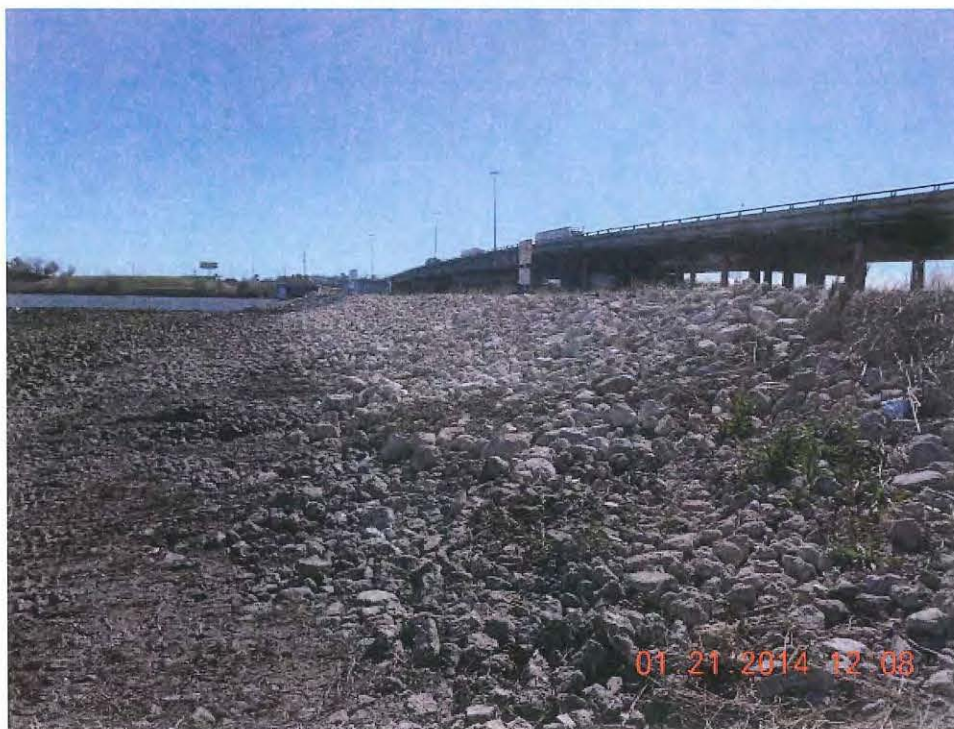
Photo 4 – Post-enhancement slope of the South Berm.

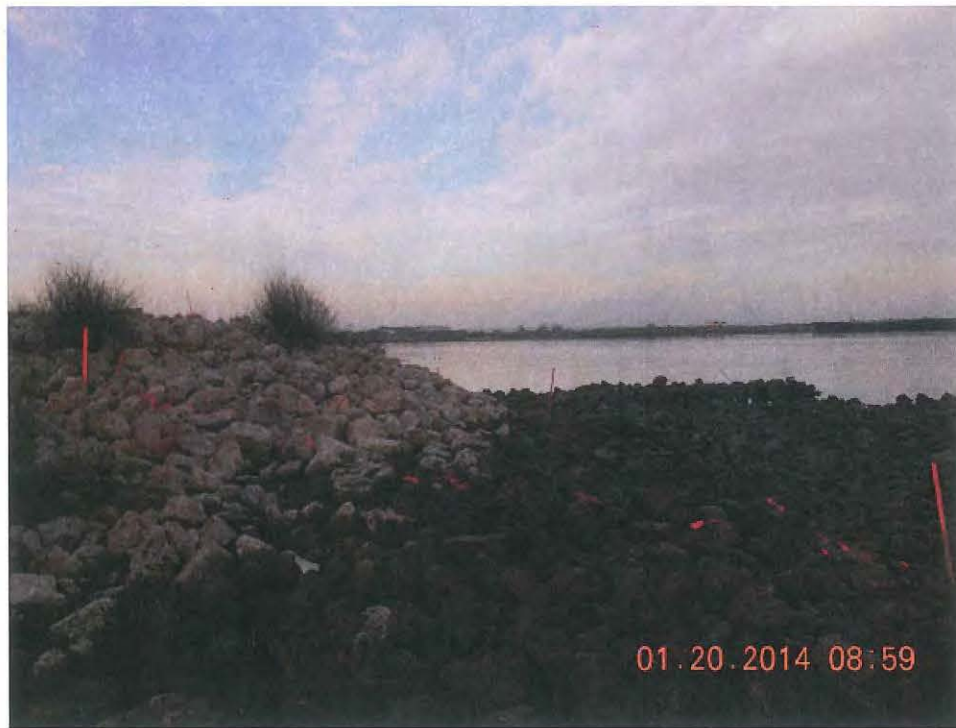
Photo 5 – Pre-enhancement slope of the north end of the Central Berm.

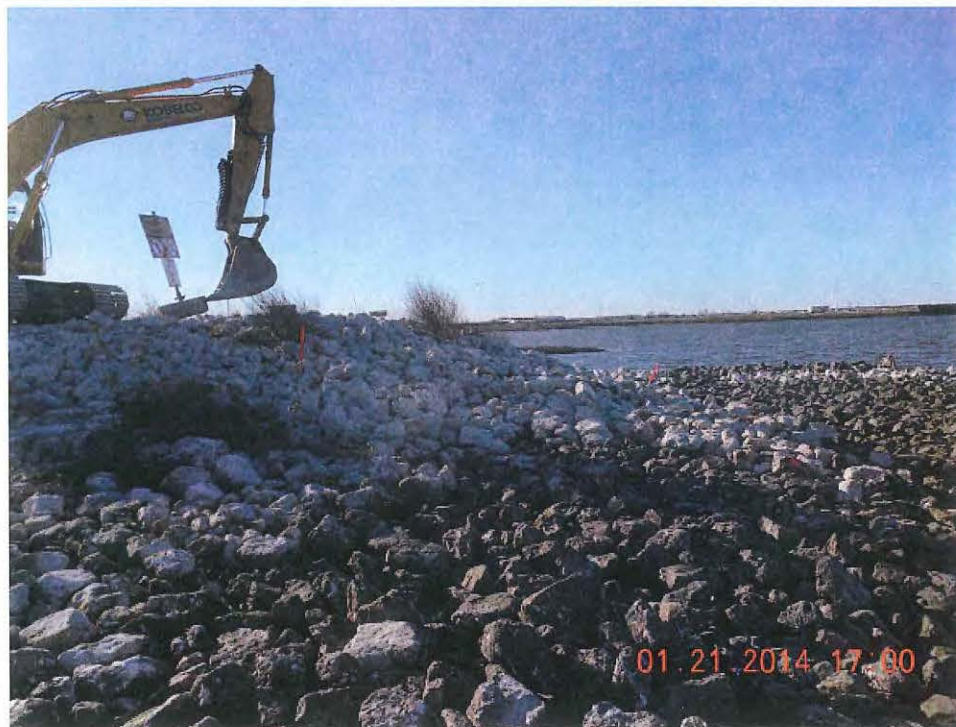
Photo 6 – Post-enhancement slope of the north end of the Central Berm.

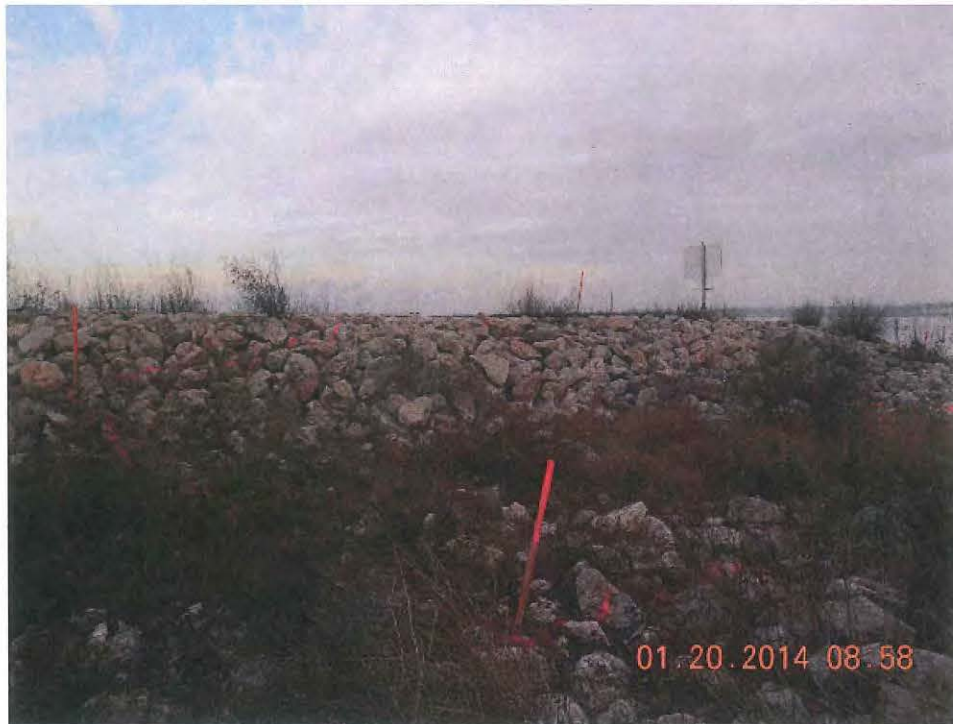
Photo 1 – Pre-enhancement slope of Area #3 on east slope of the Central Berm.

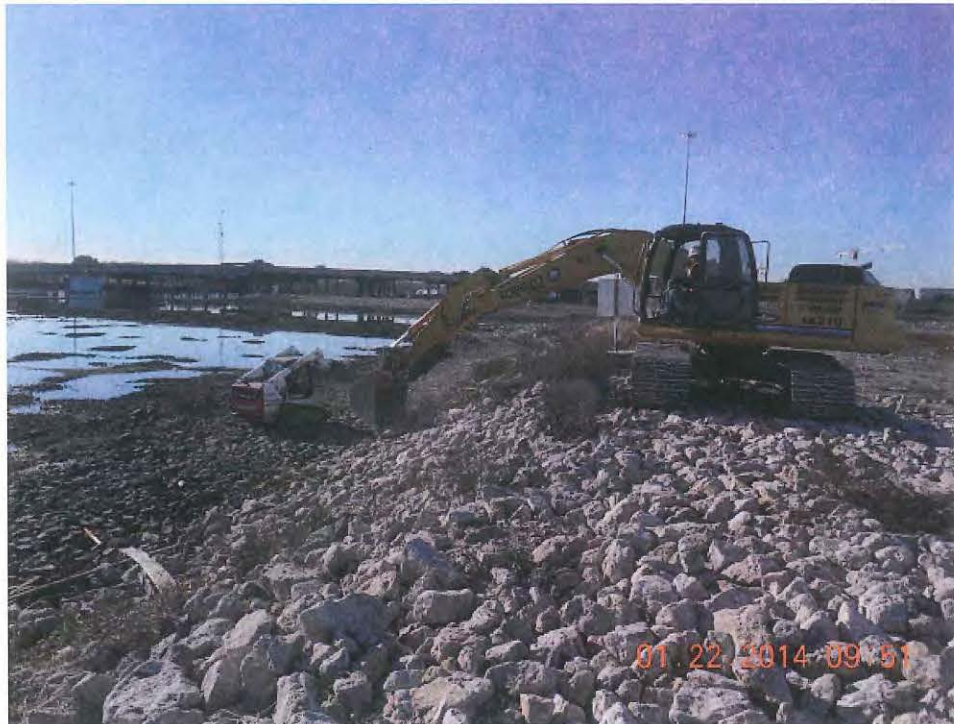
Photo 3 – Placing and grading Armor Cap D rock along east slope of the Central Berm.

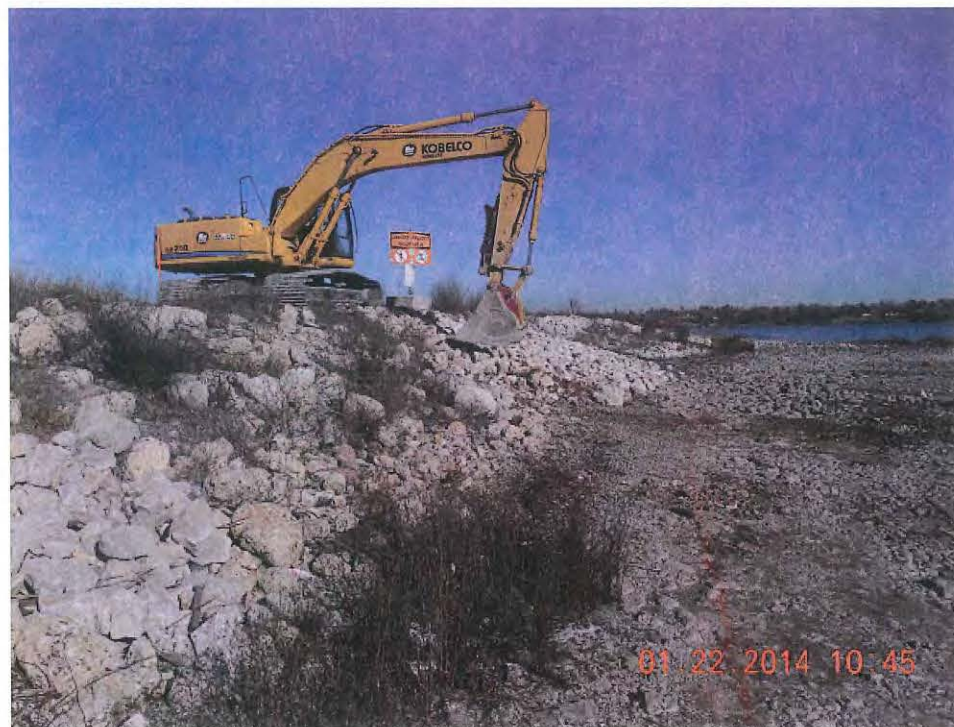
Photo 4 – Grading Armor Cap D rock along east slope of the Central Berm in Area #4.

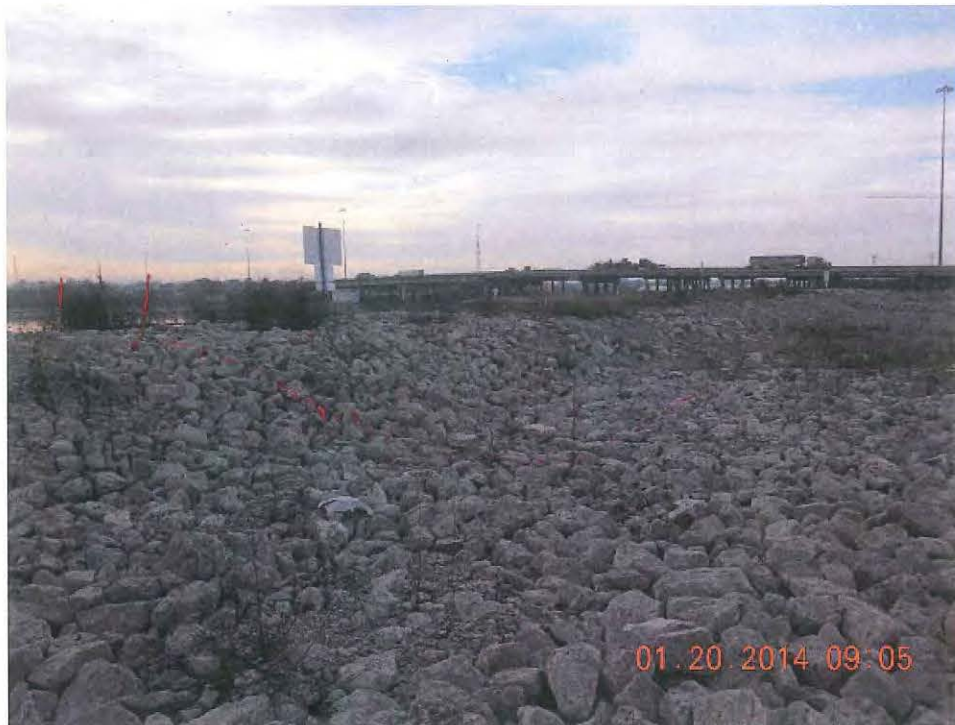
Photo 5 – Pre-enhancement slope of Area #6 on the western slope of the Central Berm.

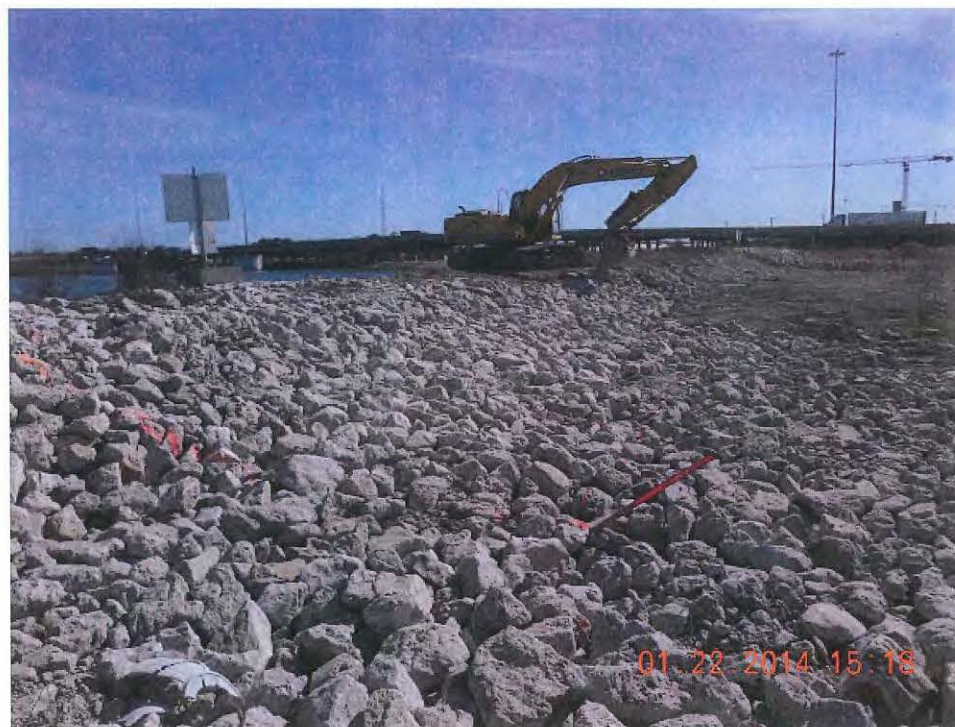
Photo 6 – Post-enhancement slope of Area #6 on the western slope of the Central Berm.

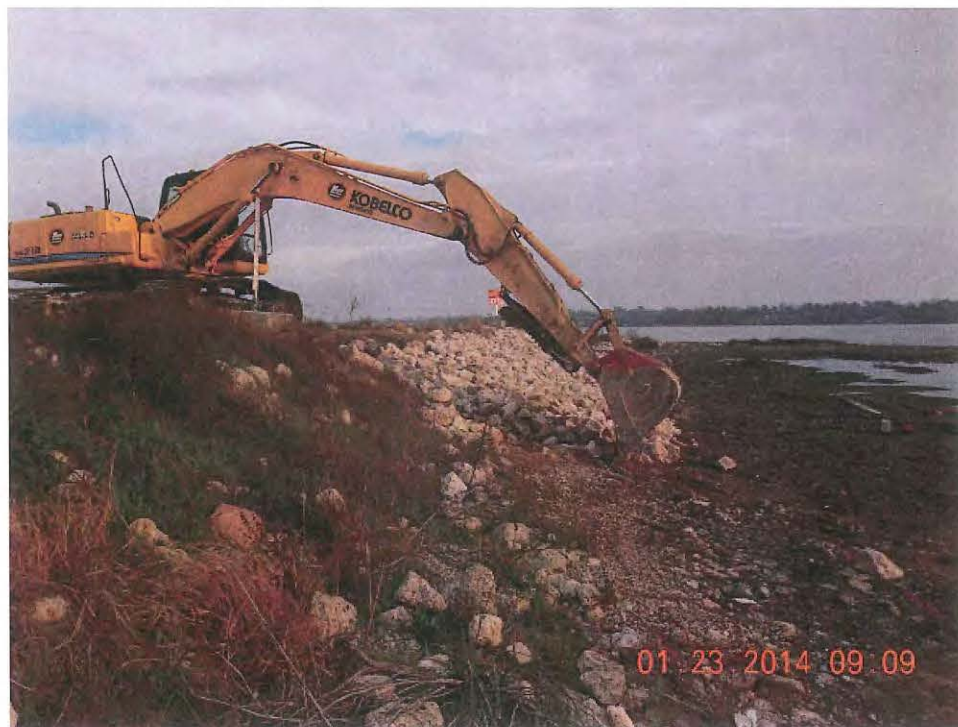
Photo 2 – Grading Armor Cap D rock on the eastern slope of the Central Berm in Area #4.

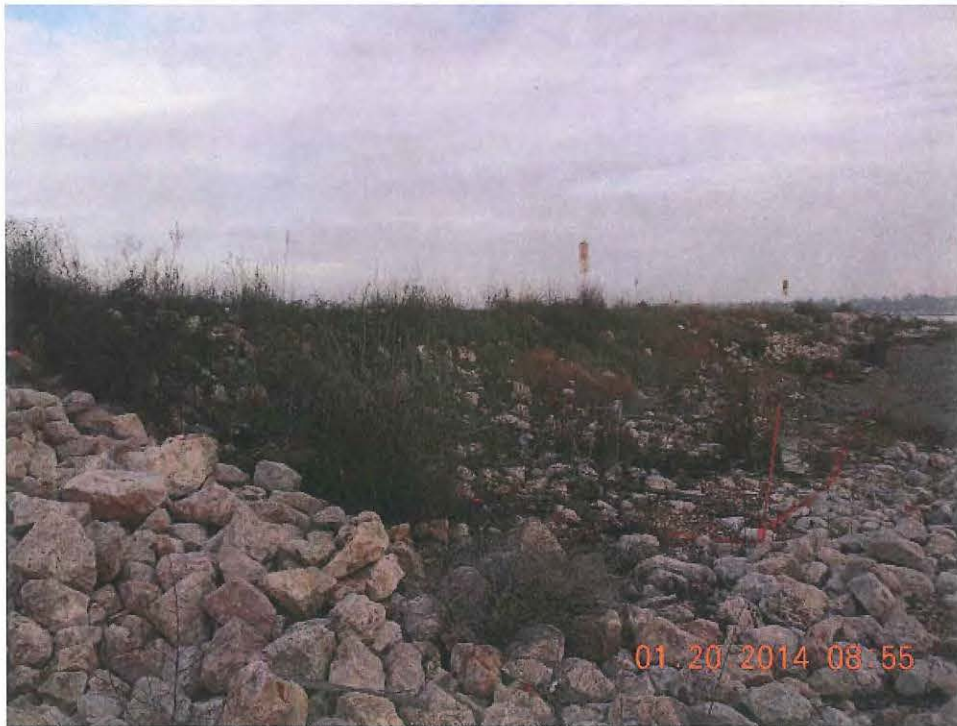
Photo 3 – Pre-enhancement slope of Area #4 on the eastern slope of the Central Berm.

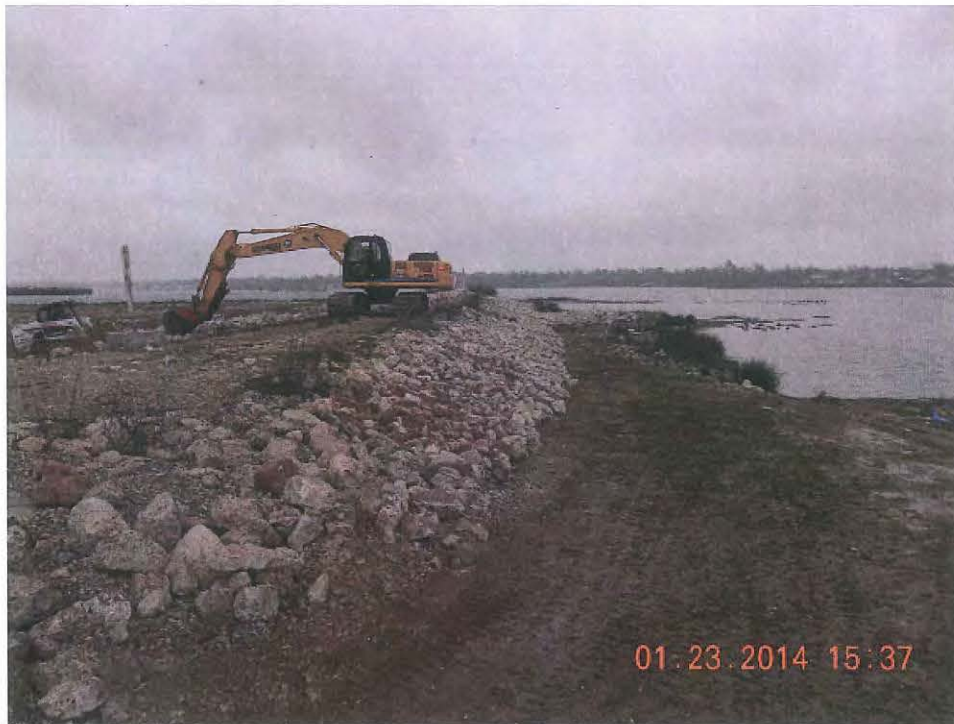
Photo 5 – Rock placement in progress at Area #5 on the eastern slope of the Central Berm.

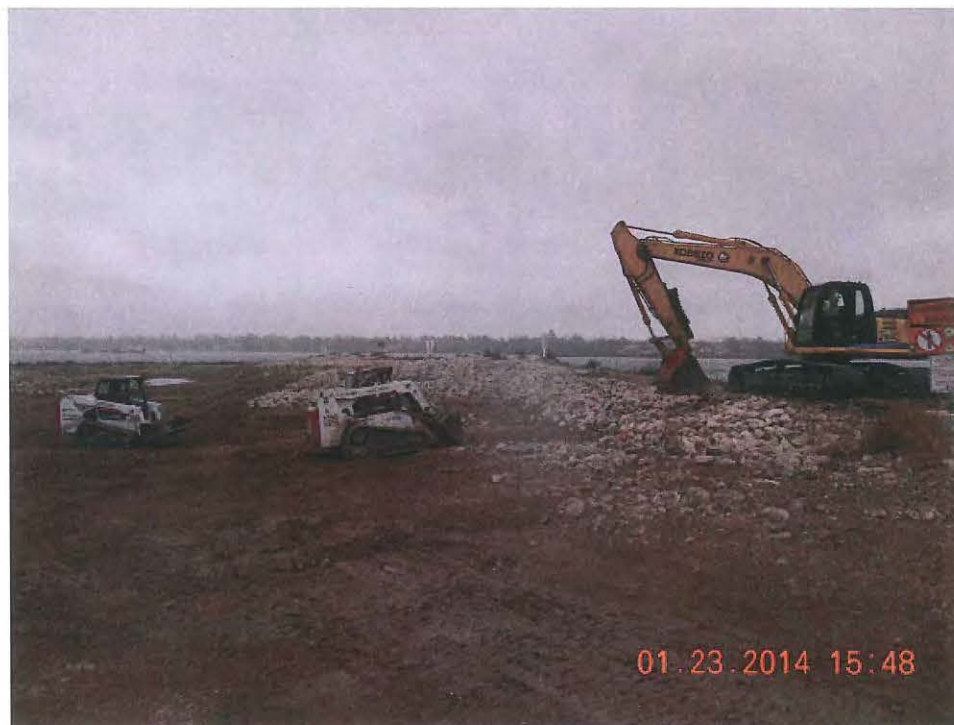
Photo 6 – Rock placement in progress at Area #7 on the western slope of the Central Berm.

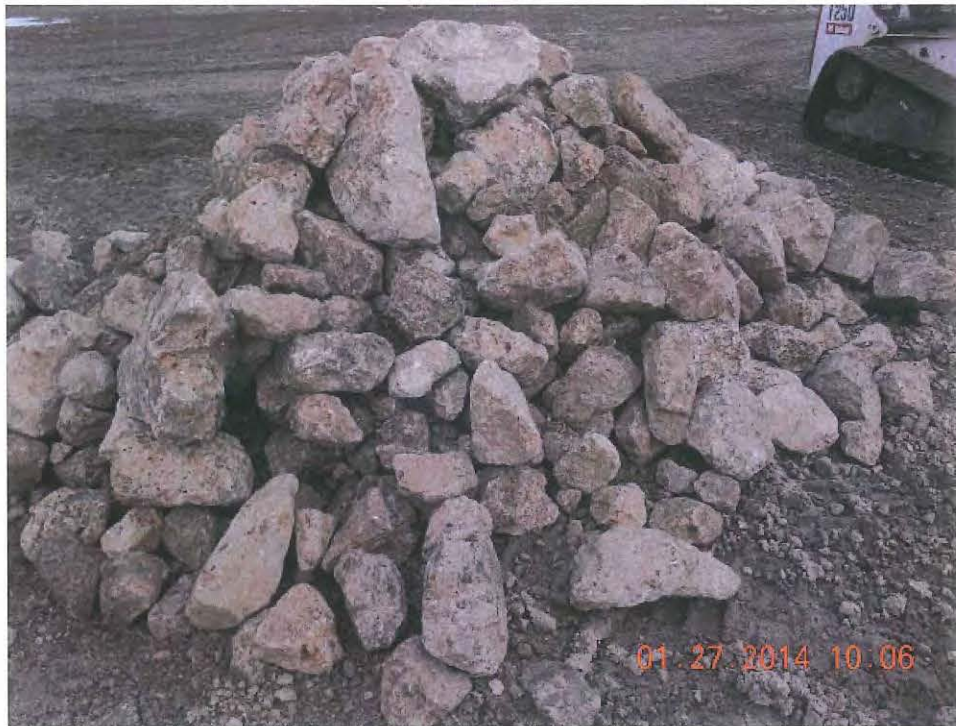
Photo 1 – Close-up of Armor Cap D rock at the on-site stockpile area.

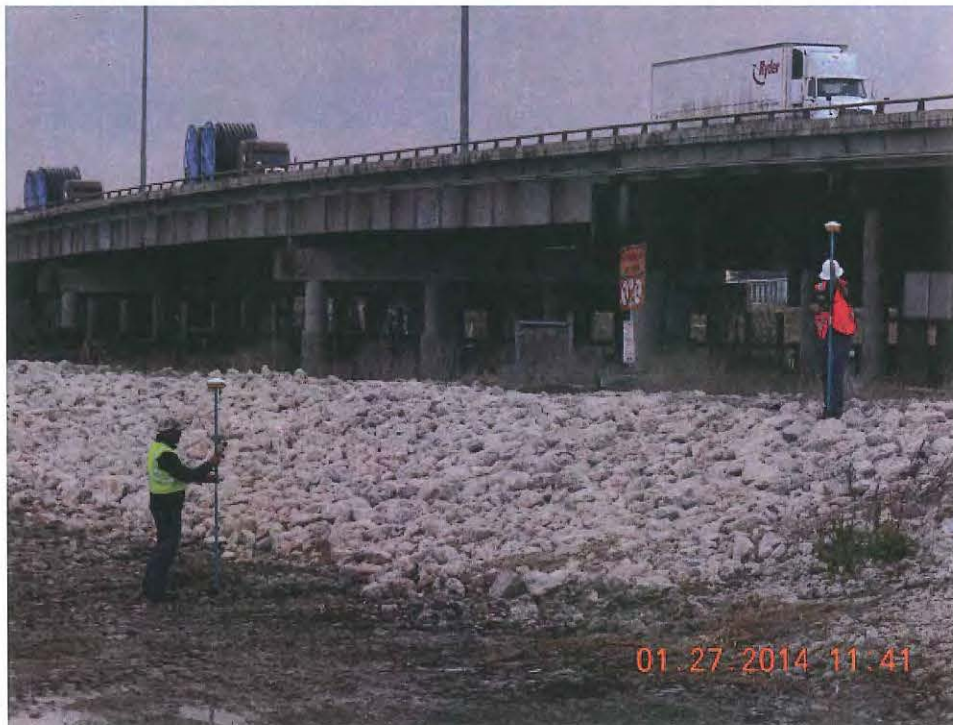
Photo 2 – Collecting survey data along the South Berm at Area #1.

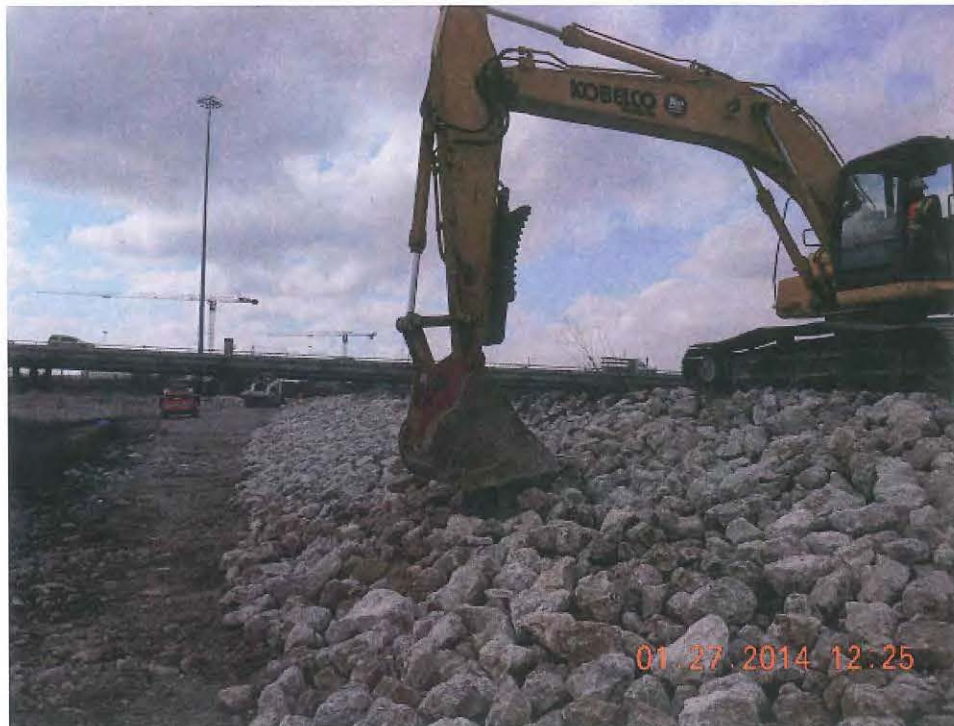
Photo 3 – Grading Armor Cap D rock on the eastern slope of the Central Berm in Area #5.

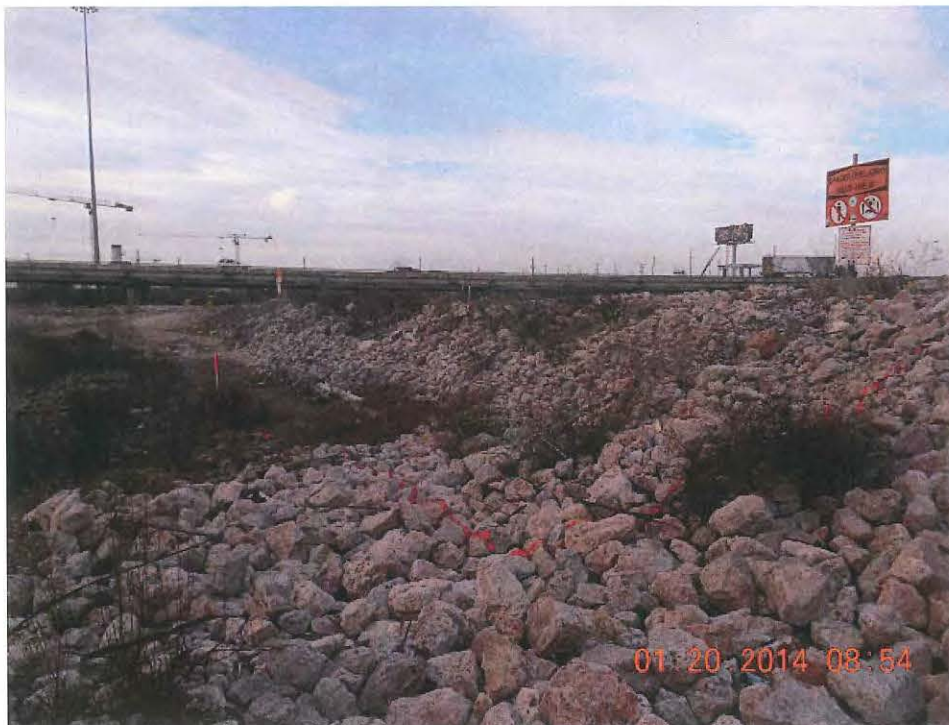
Photo 4 – Pre-enhancement slope of Area #5 on the eastern slope of the Central Berm.

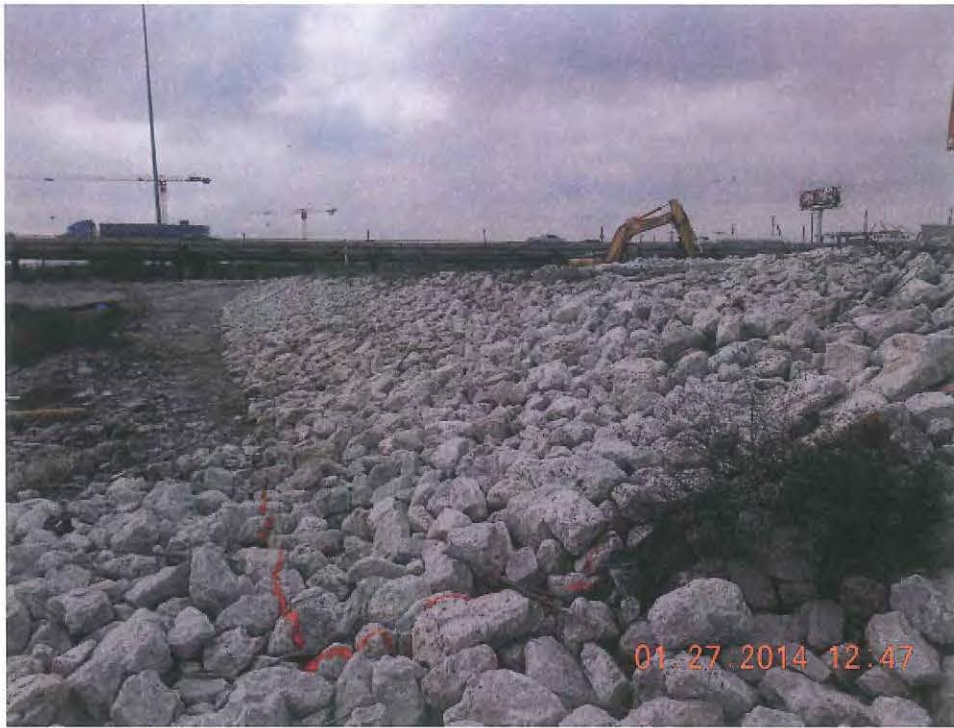
Photo 5 – Post-enhancement slope of Area #5 on the eastern slope of the Central Berm.
